Aluminum Lithium Alloy 2195 Fusion Welding Improvements with New Filler Wire

**AMPET 2000
Huntsville, AL**

***Carolyn Russell
NASA
Marshall Space Flight Center
Huntsville, AL.
256-544-2705
carolyn.russell@msfc.nasa.gov***

***Gerry Bjorkman
Lockheed Martin Space Systems Company
Michoud Operations
Huntsville, AL.
256-961-4438
gerry.bjorkman@msfc.nasa.gov***

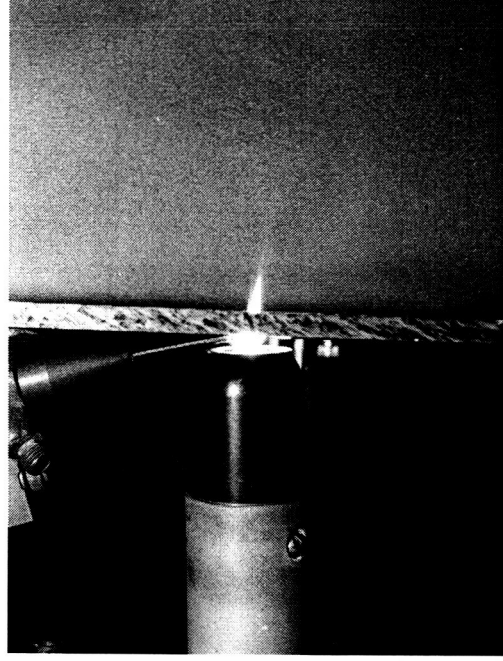
Variable Polarity Plasma Arc Welding

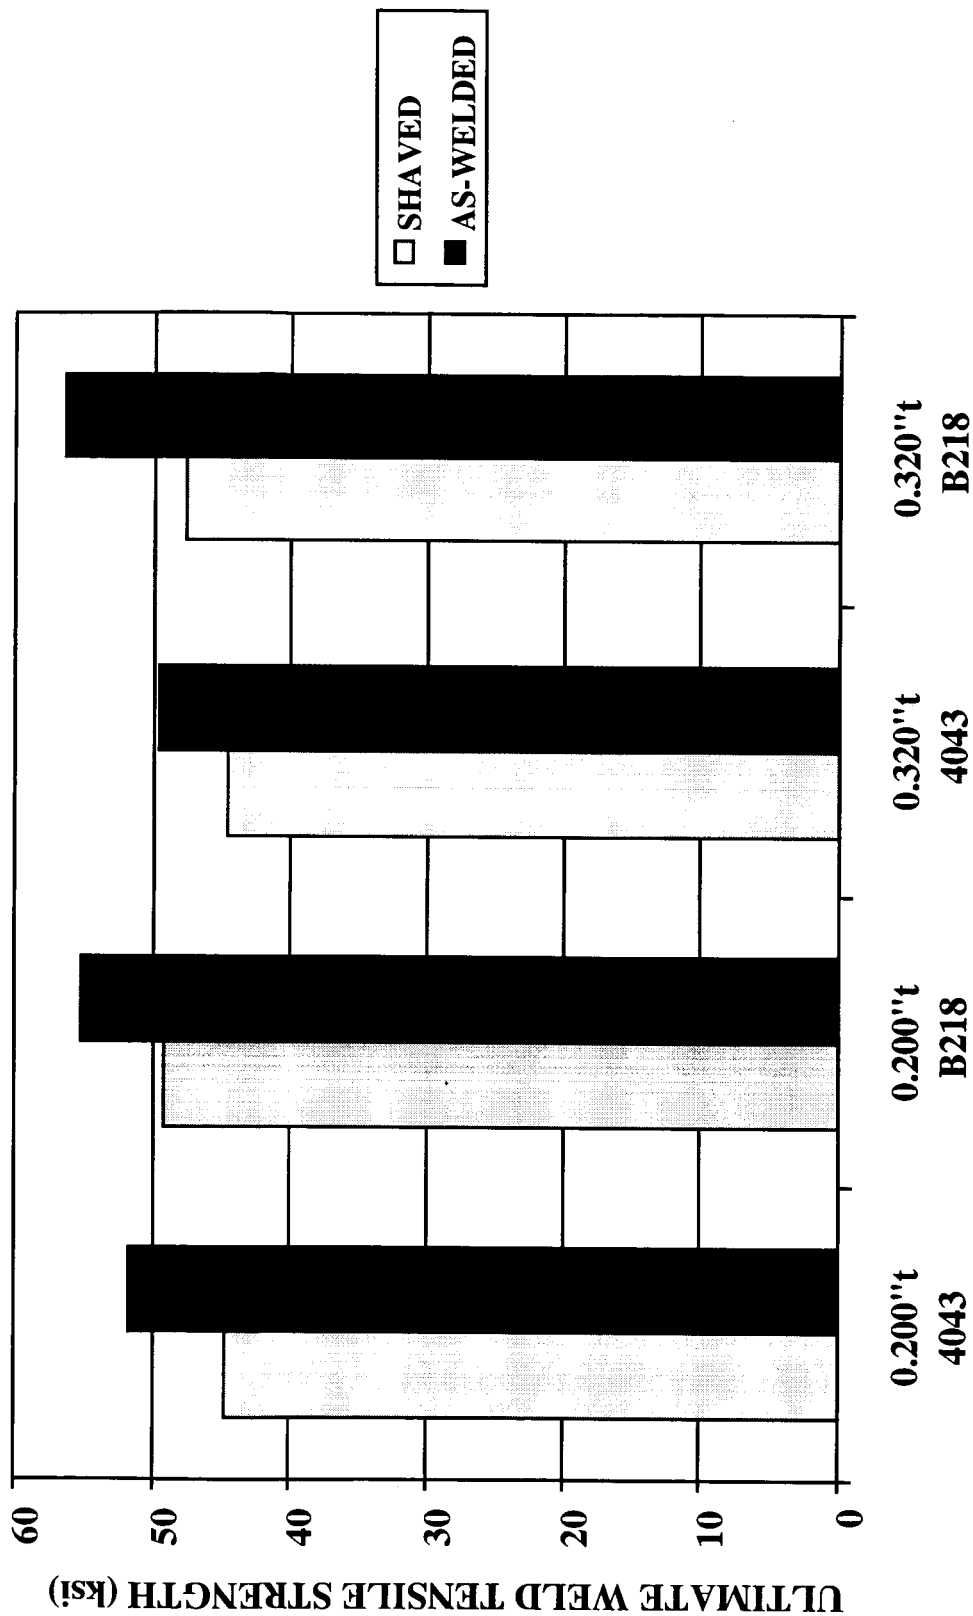
2195T8M4 VPPA Weld Ultimate Tensile Strength

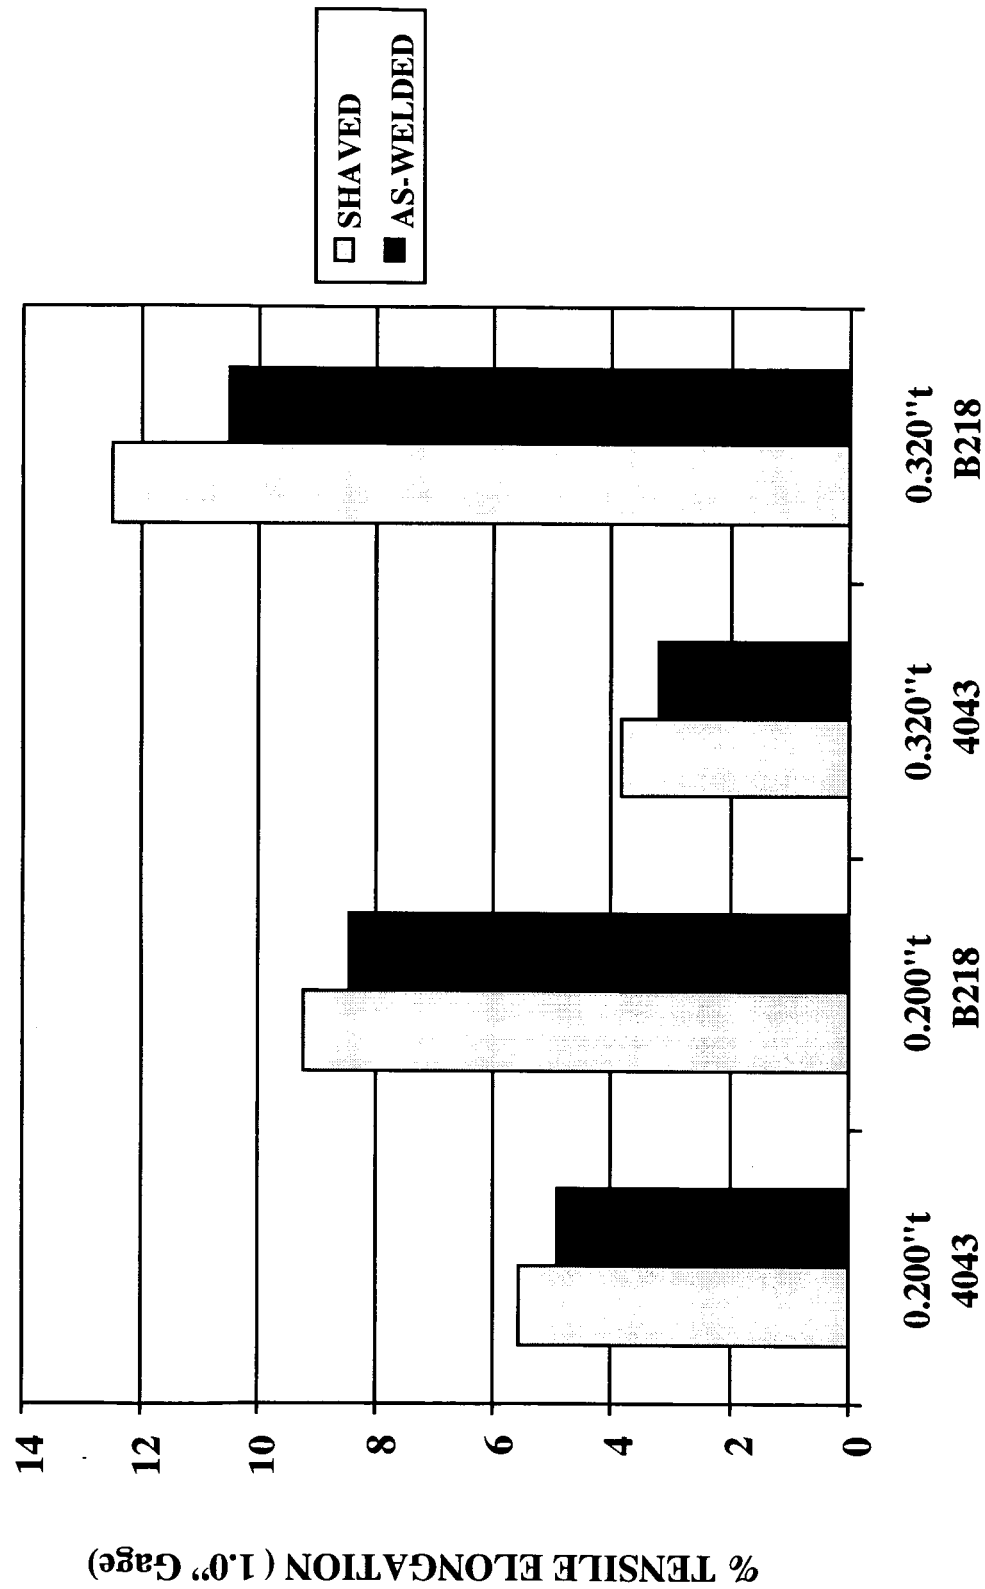
2195T8M4 VPPA Weld Tensile Elongation

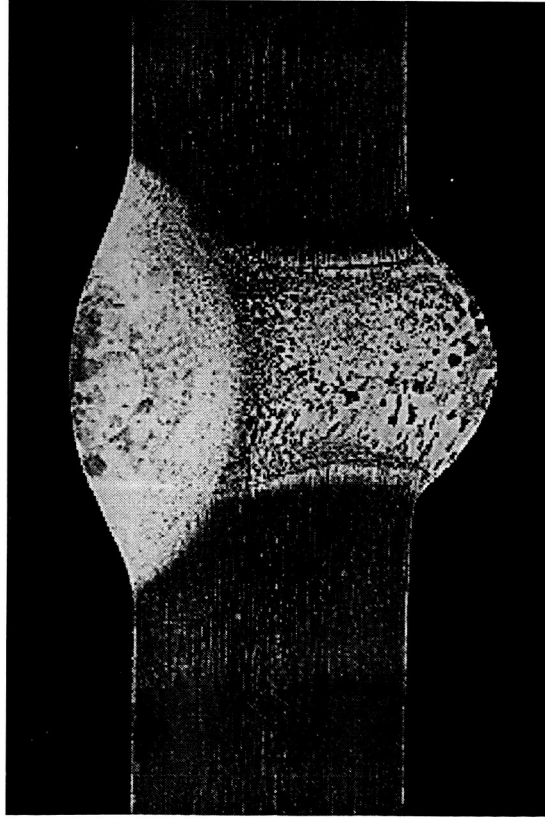
0.320t 2195 PLATE TO 2195 PLATE VPPAW

4043 WELD FILLER WIRE

10X Original Magnification

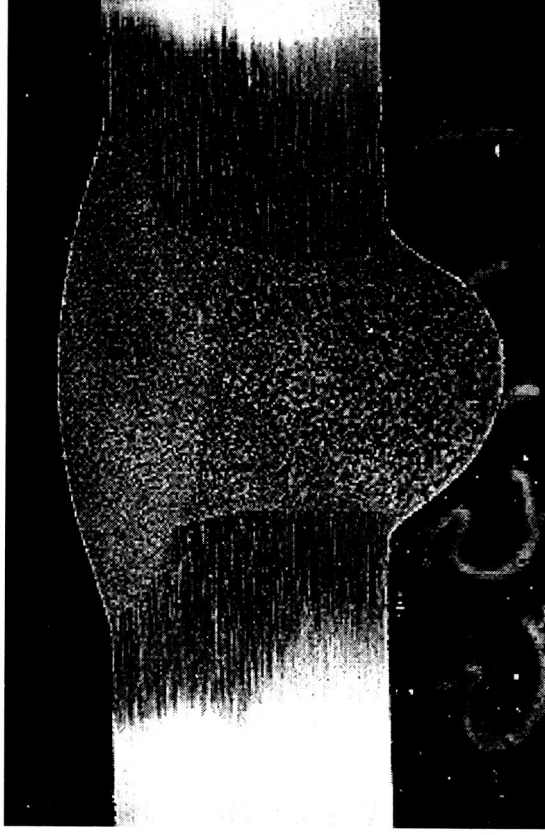
B218 WELD FILLER WIRE

10X Original Magnification

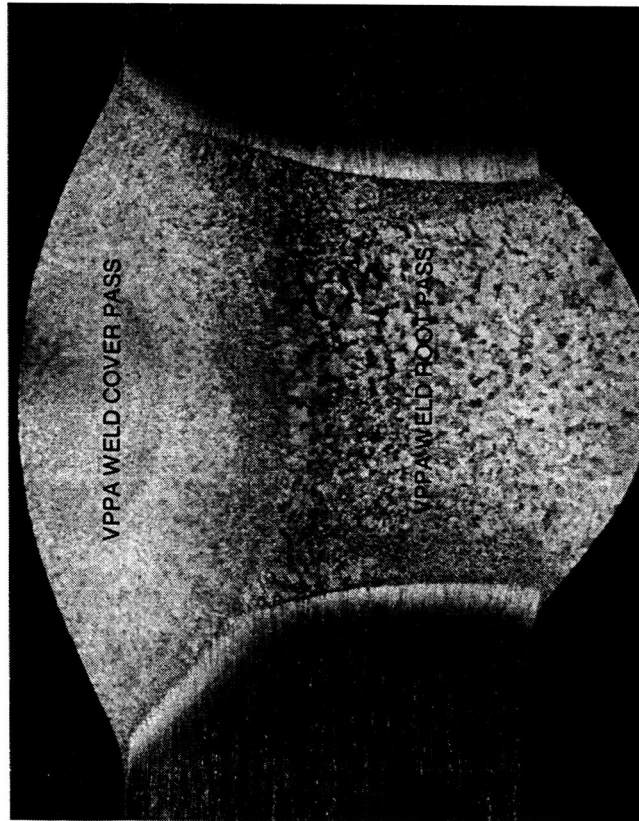
B218 VPPA Weld Grain Structure

0.200t 2195 PLATE TO 2195 PLATE VPPAW

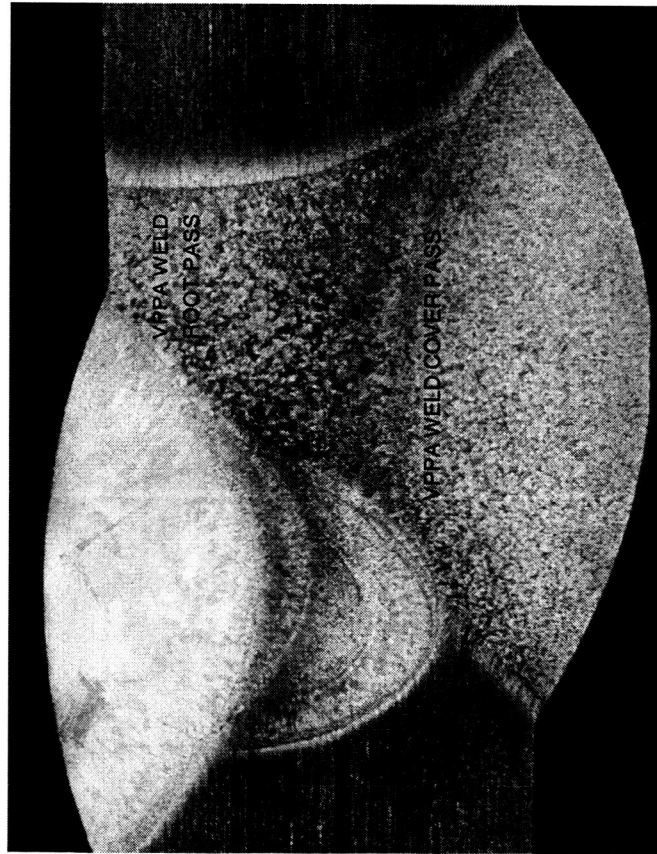
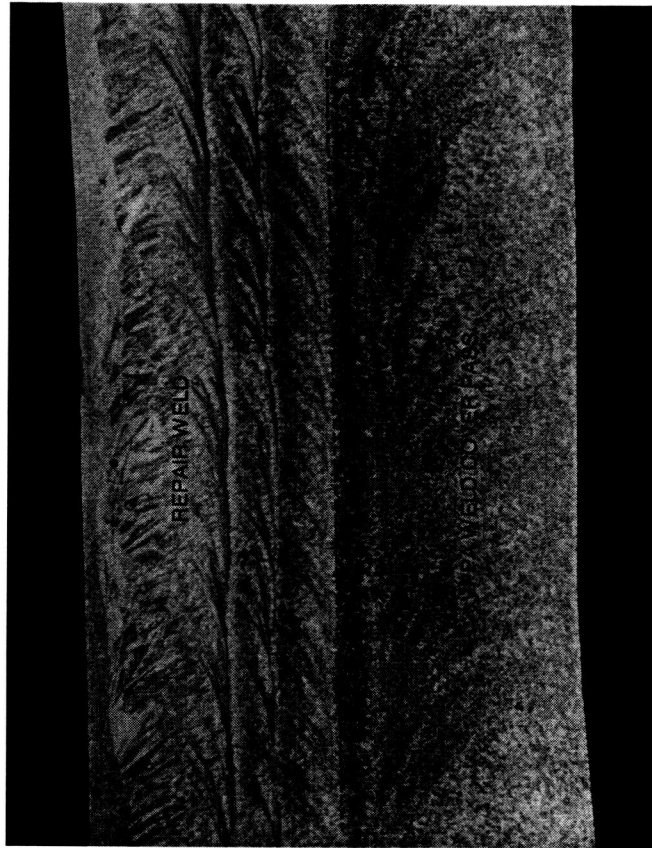
B218 GTA Repair Weld Grain Structure

R1 GTA Repair 0.200t 2195 PLATE TO 2195 PLATE VPPAW

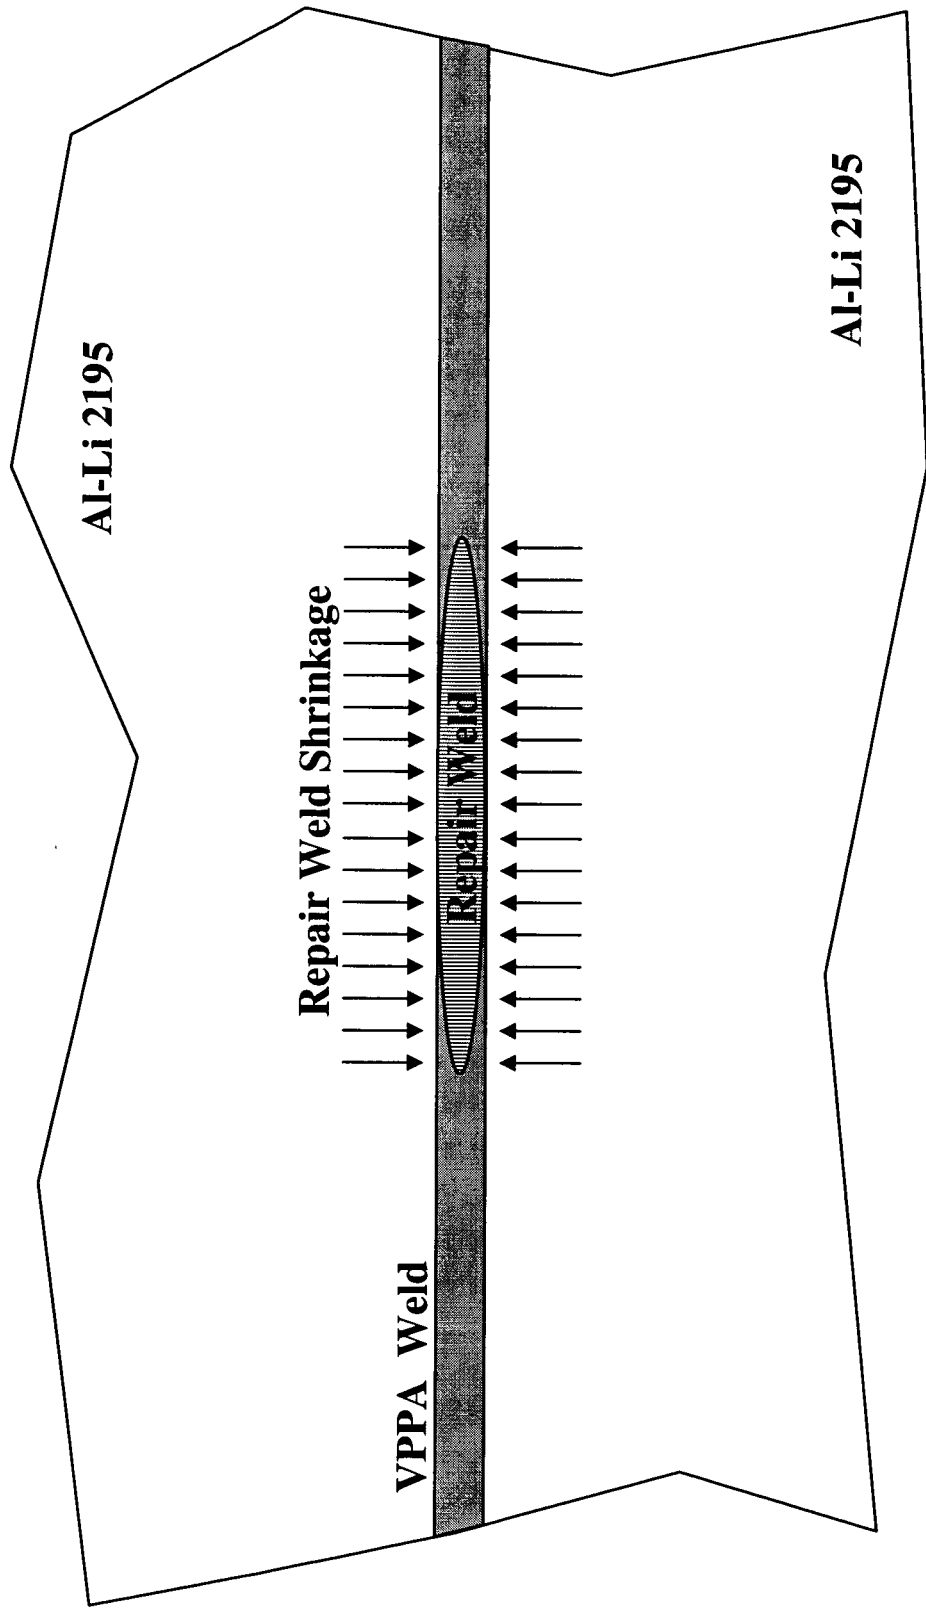
2195 Repair Weld Residual Stresses

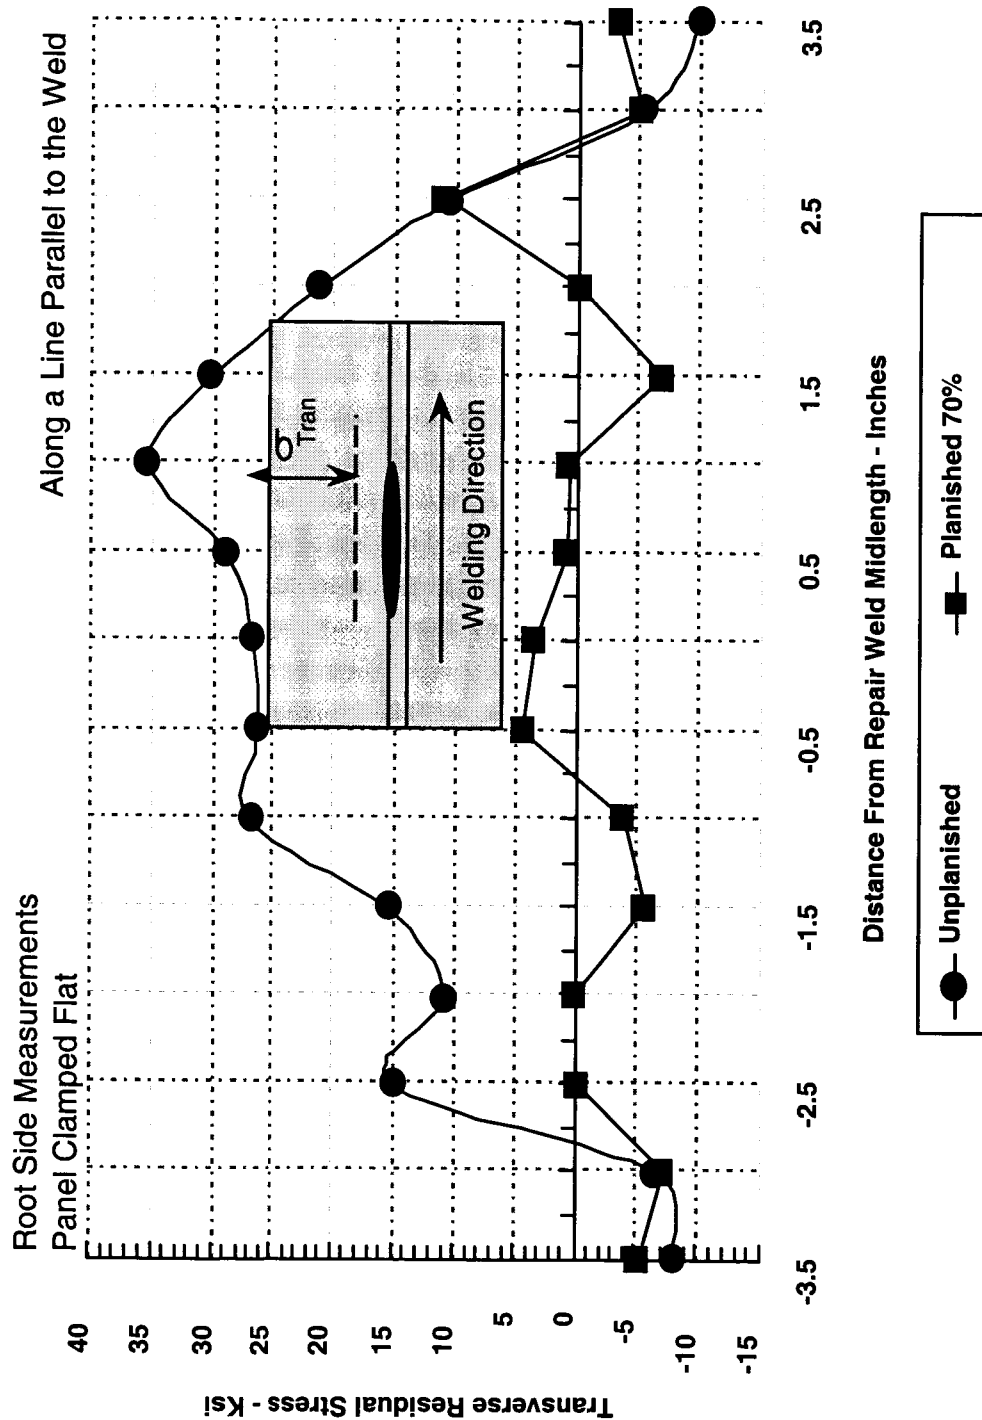
2195 Repair Weld Residual Stresses

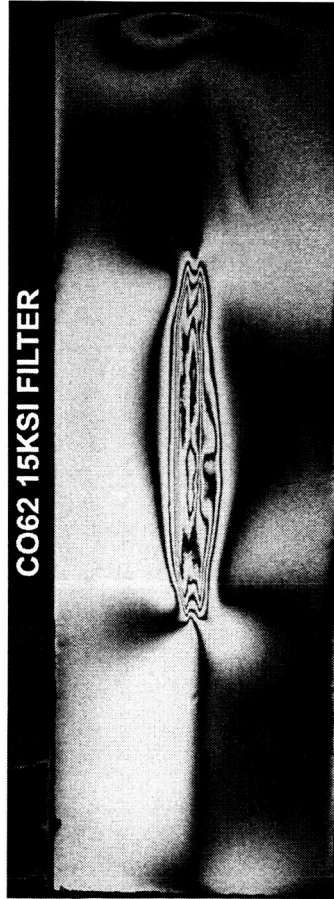
R5 GTA Repair 0.200t 2195 PLATE TO 2195 PLATE VPPAW

Photostress of Unplanished Repair Weld

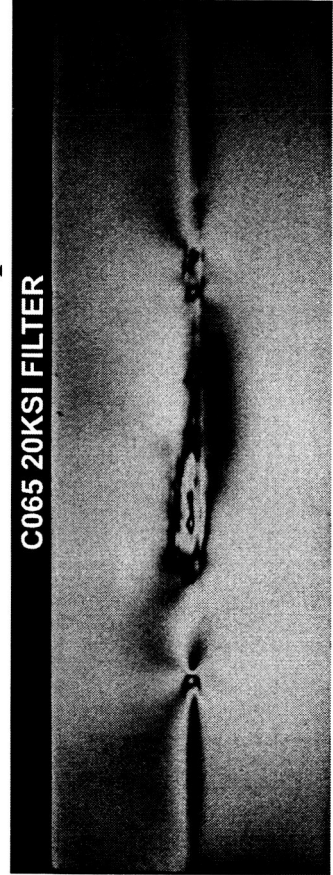
Photostress of Planished Repair Weld

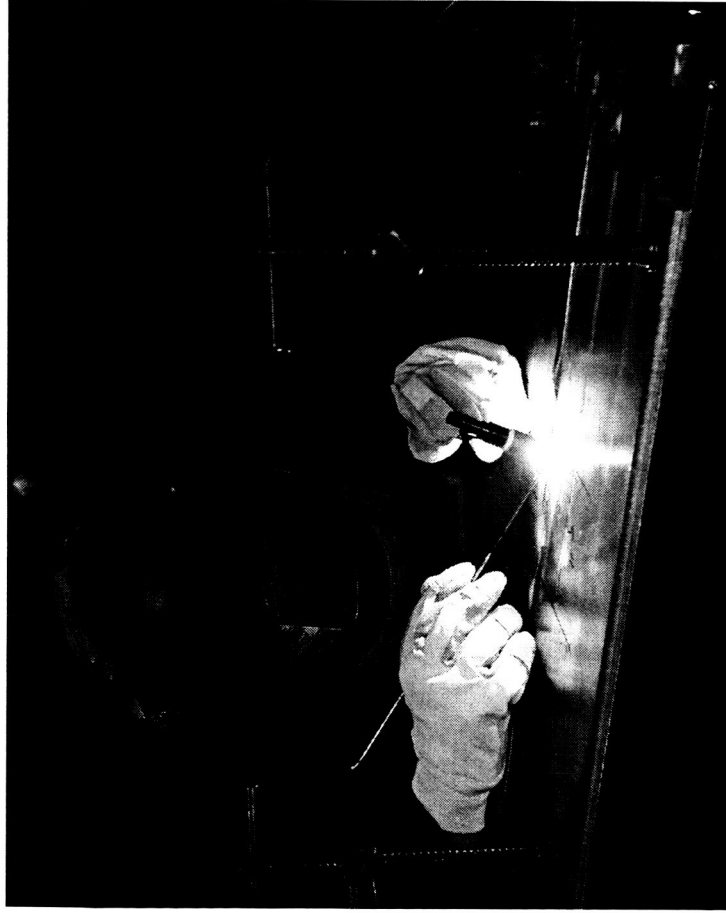
- 14" X 24" Standard Repair Weld Panel

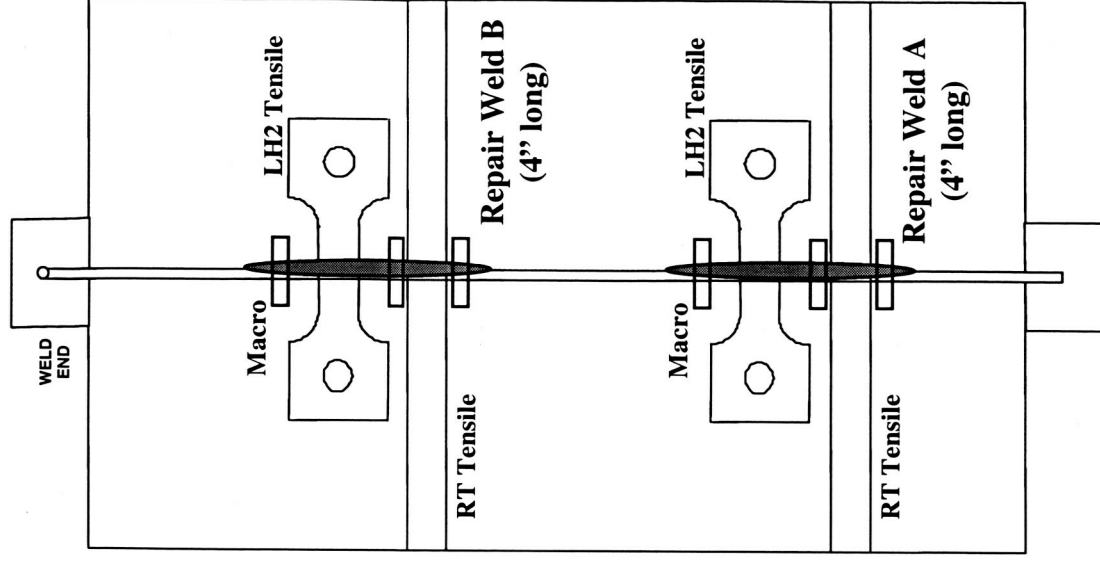
Manual GTA Repair Welding

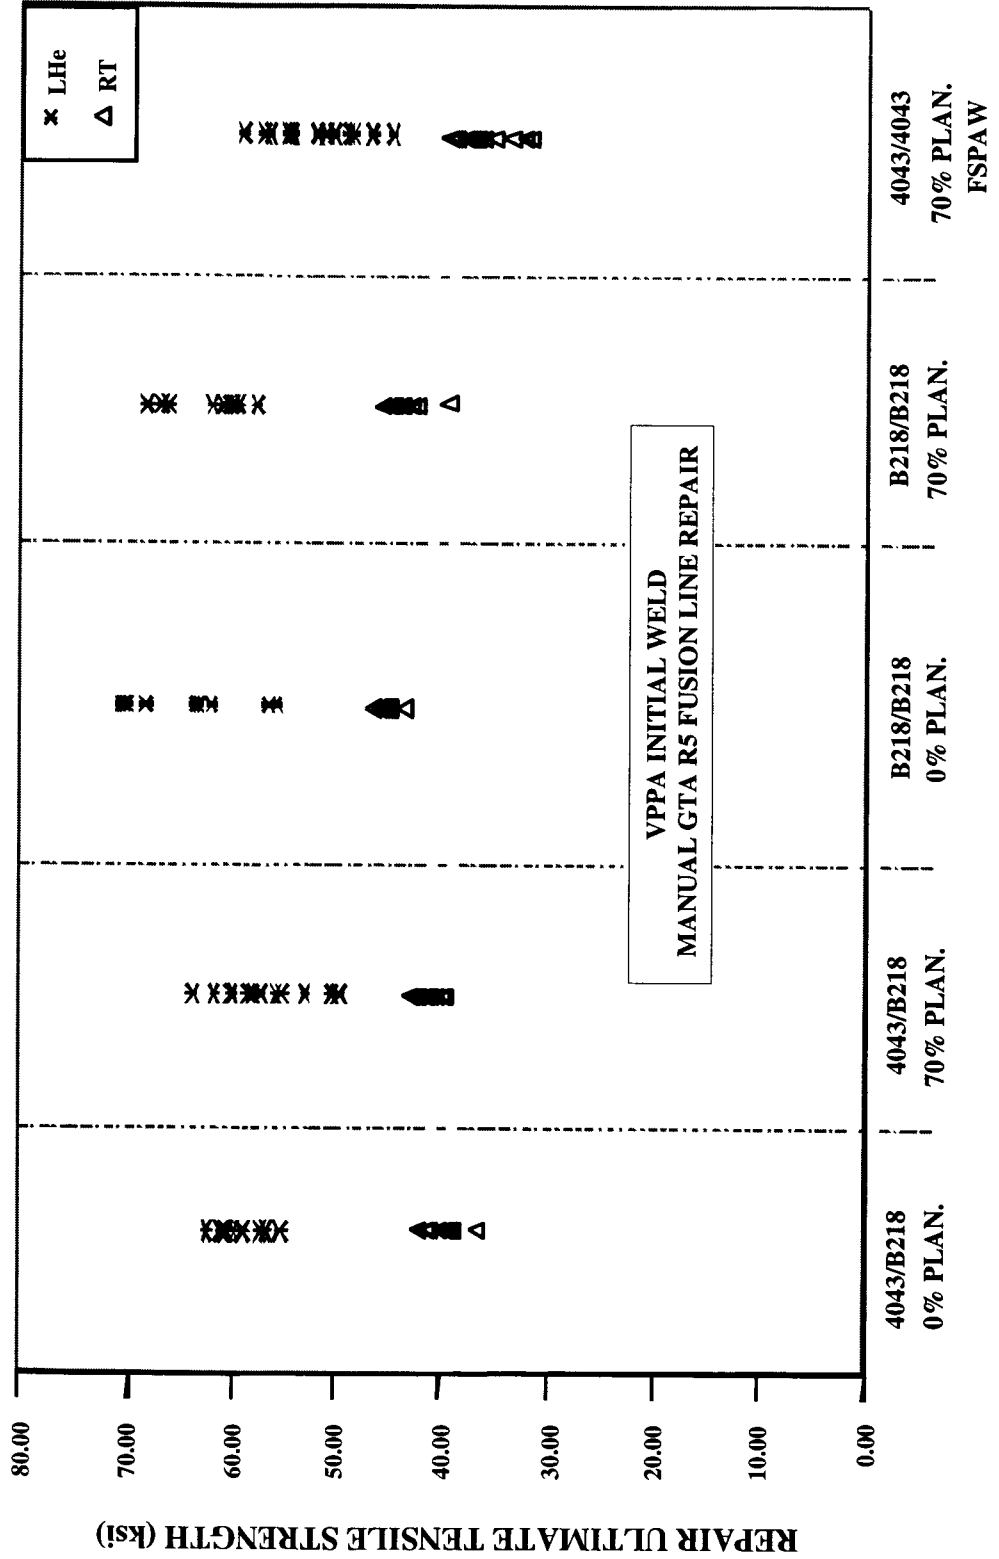
0.200"t 2195T8M4 Repair Weld Ultimate Tensile Strength -Coupon Level

- B218 weld filler wire displayed higher repair weld tensile strength and ductility compared to 4043.
- Unplanished and planished B218 repair welds exceeded the current SLWT 4043 repair weld tensile strength requirement.
- B218 repair weld simulated service results surpassed 4043 repair welds and were comparable to 2195 initial welds made with 4043.
- B218 displays a high potential for improving SLWT production through increased repair weldability and the reduction/elimination of planishing for the removal of repair weld residual stresses.

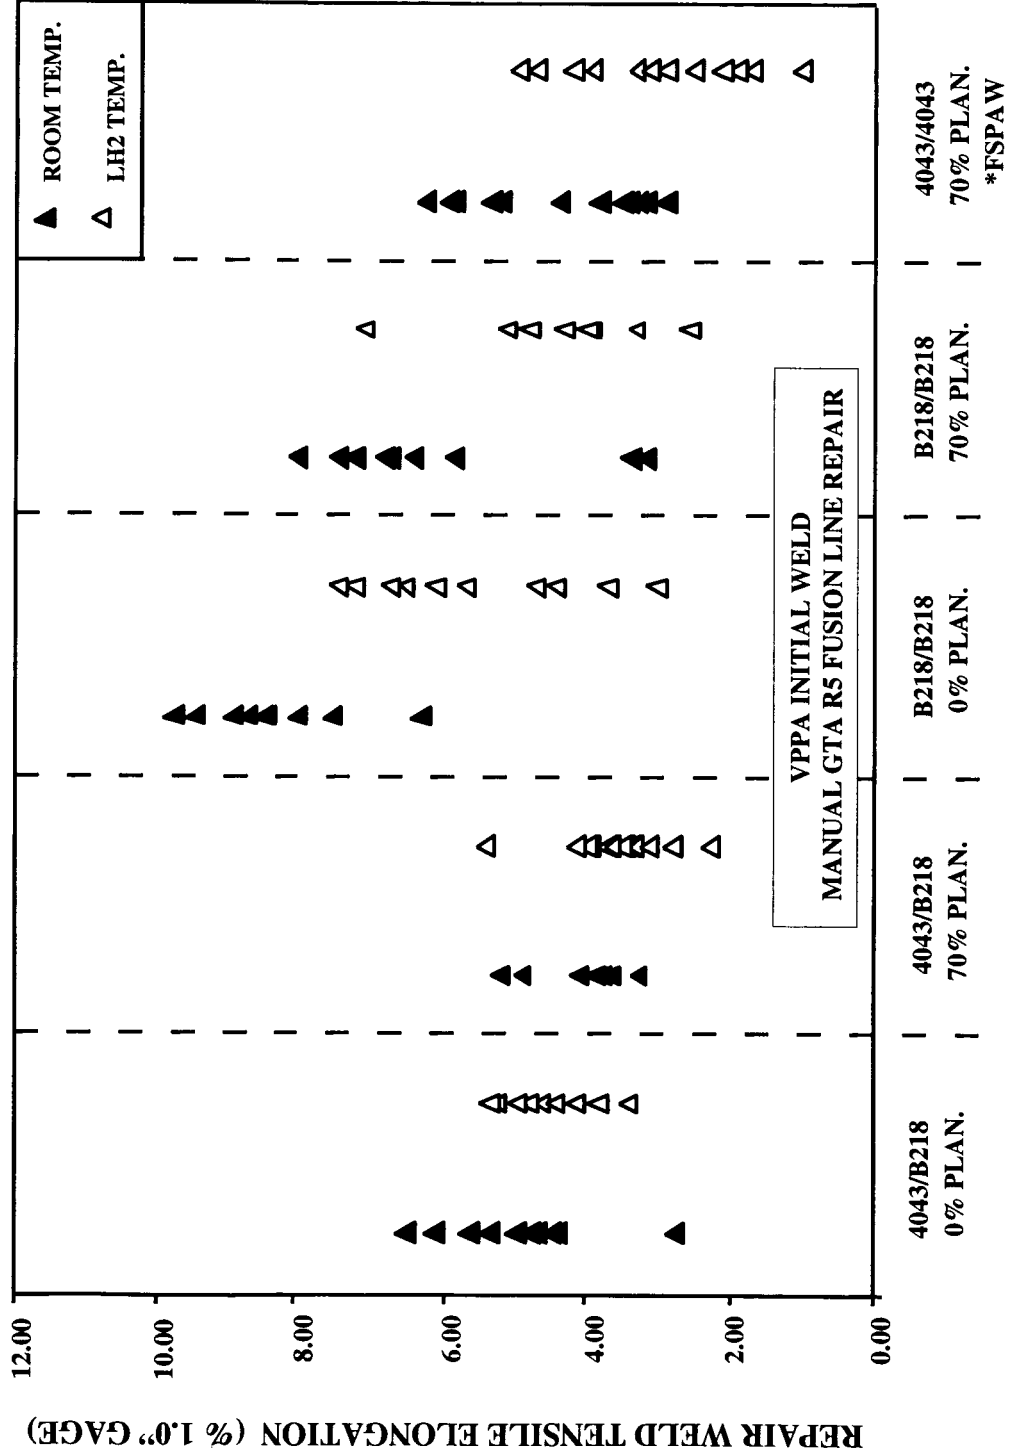
0.200" 2195T8M4 Repair Weld Ultimate Tensile Elongation - Coupon Level

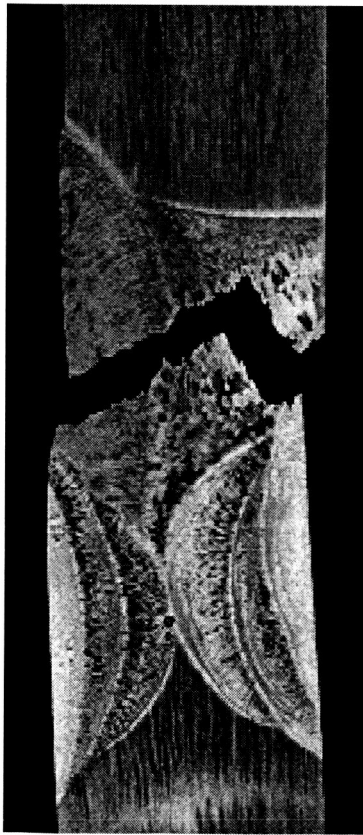
- 4043/B218 0% Planished

7X Original Magnification

C008-RT02
RT Tensile Test
36.2 ksi / 2.74% El. 1" gage

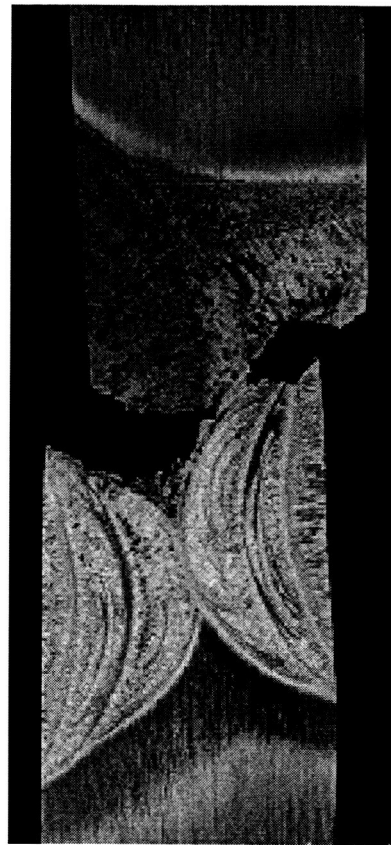
7X Original Magnification

C009-CT01
LH2 Tensile Test
62.5 ksi / 3.4% El. 1" gage

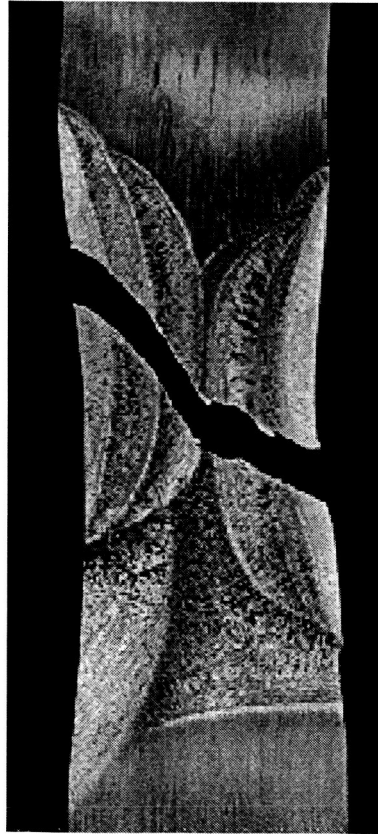
- B218/B218 0% Planished

7X Original Magnification

C080-CT01
LH2 Tensile Test
68.1 ksi / 7.40% El. 1" gage

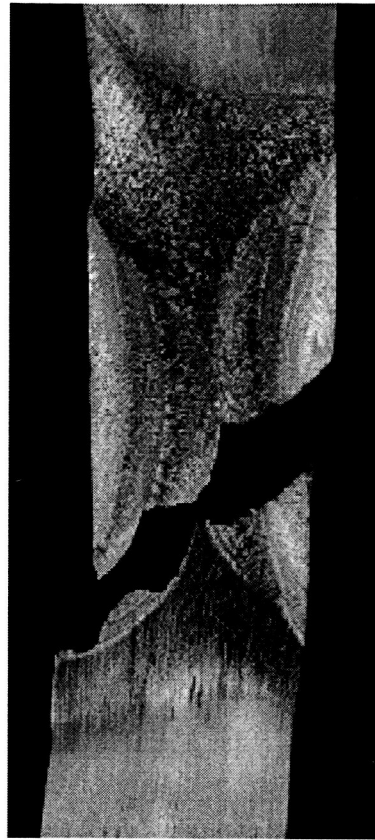
C080-RT01
RT Tensile Test
45.2 ksi / 9.75% El. 1" gage

7X Original Magnification

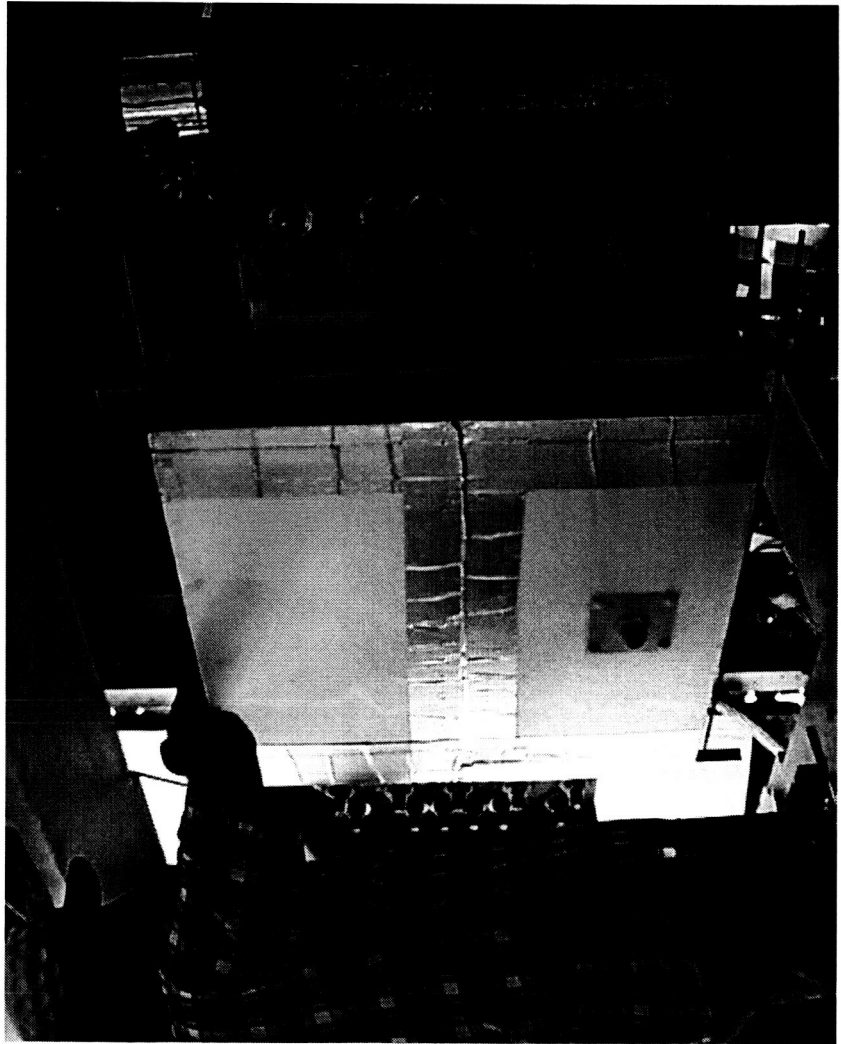
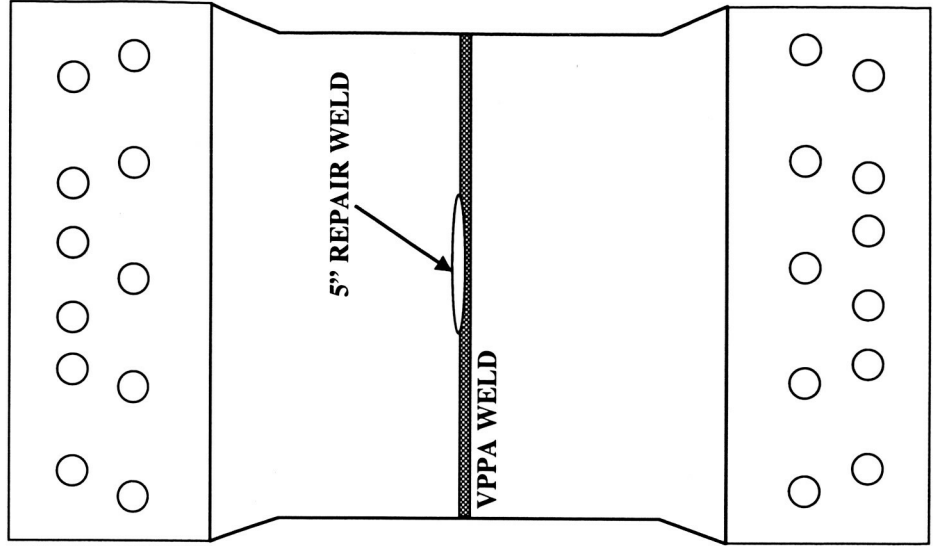
- 19" X 48" Repair Weld Wide Panel

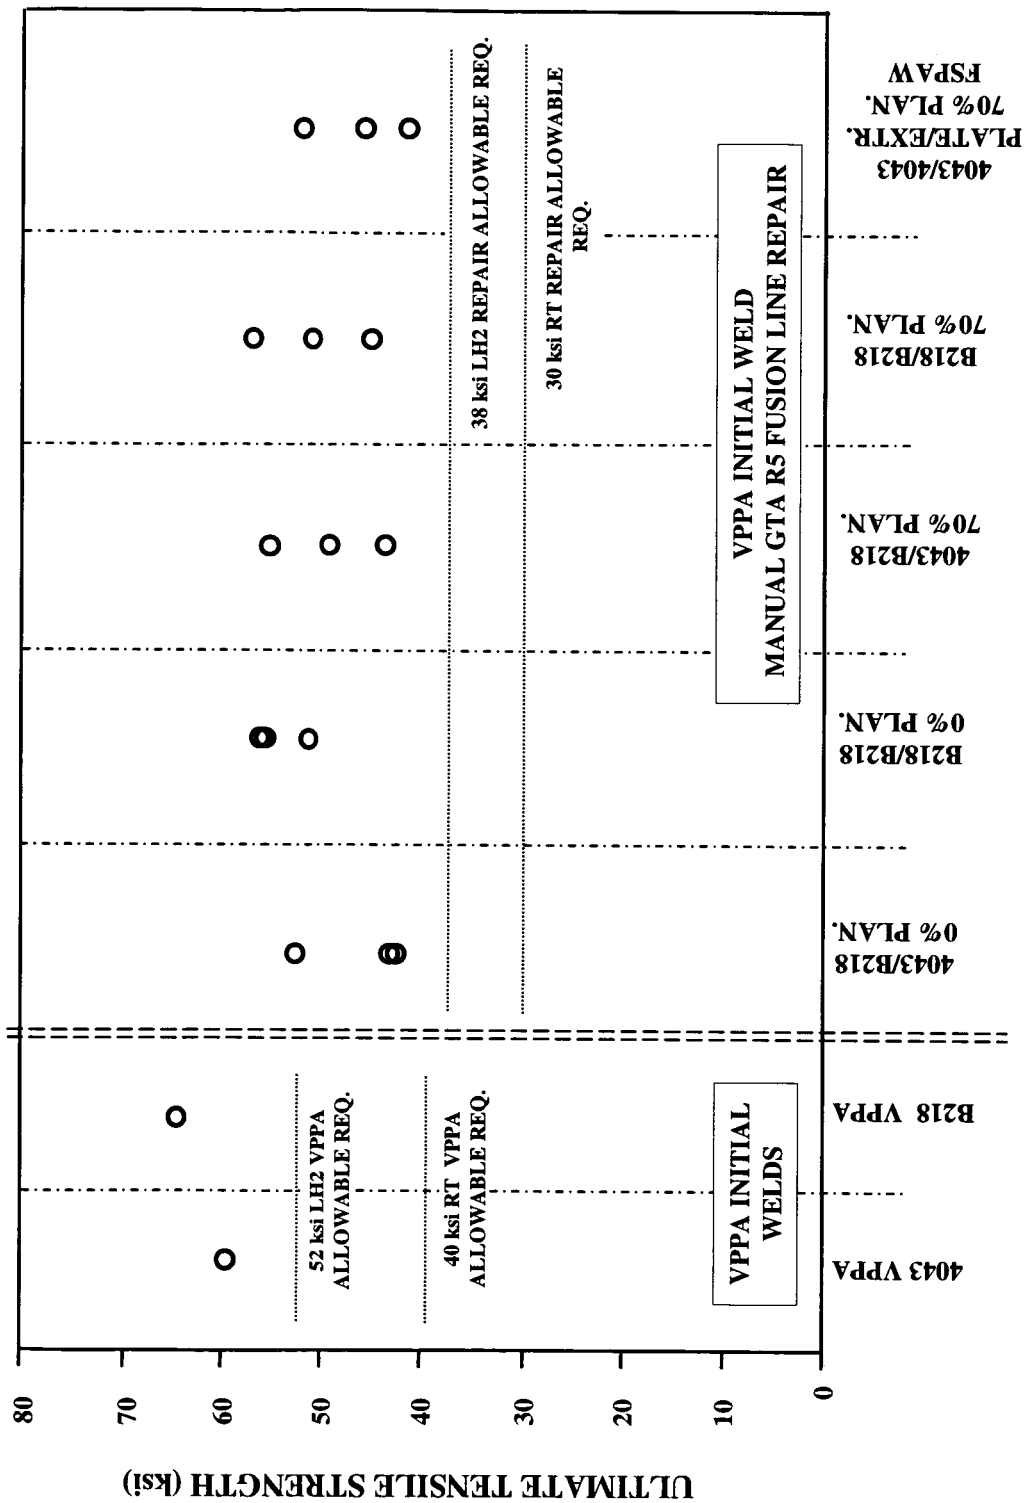
0.200t 2195T8M4 Structural Simulation Panel Weld Tensile Strength (-423°F)

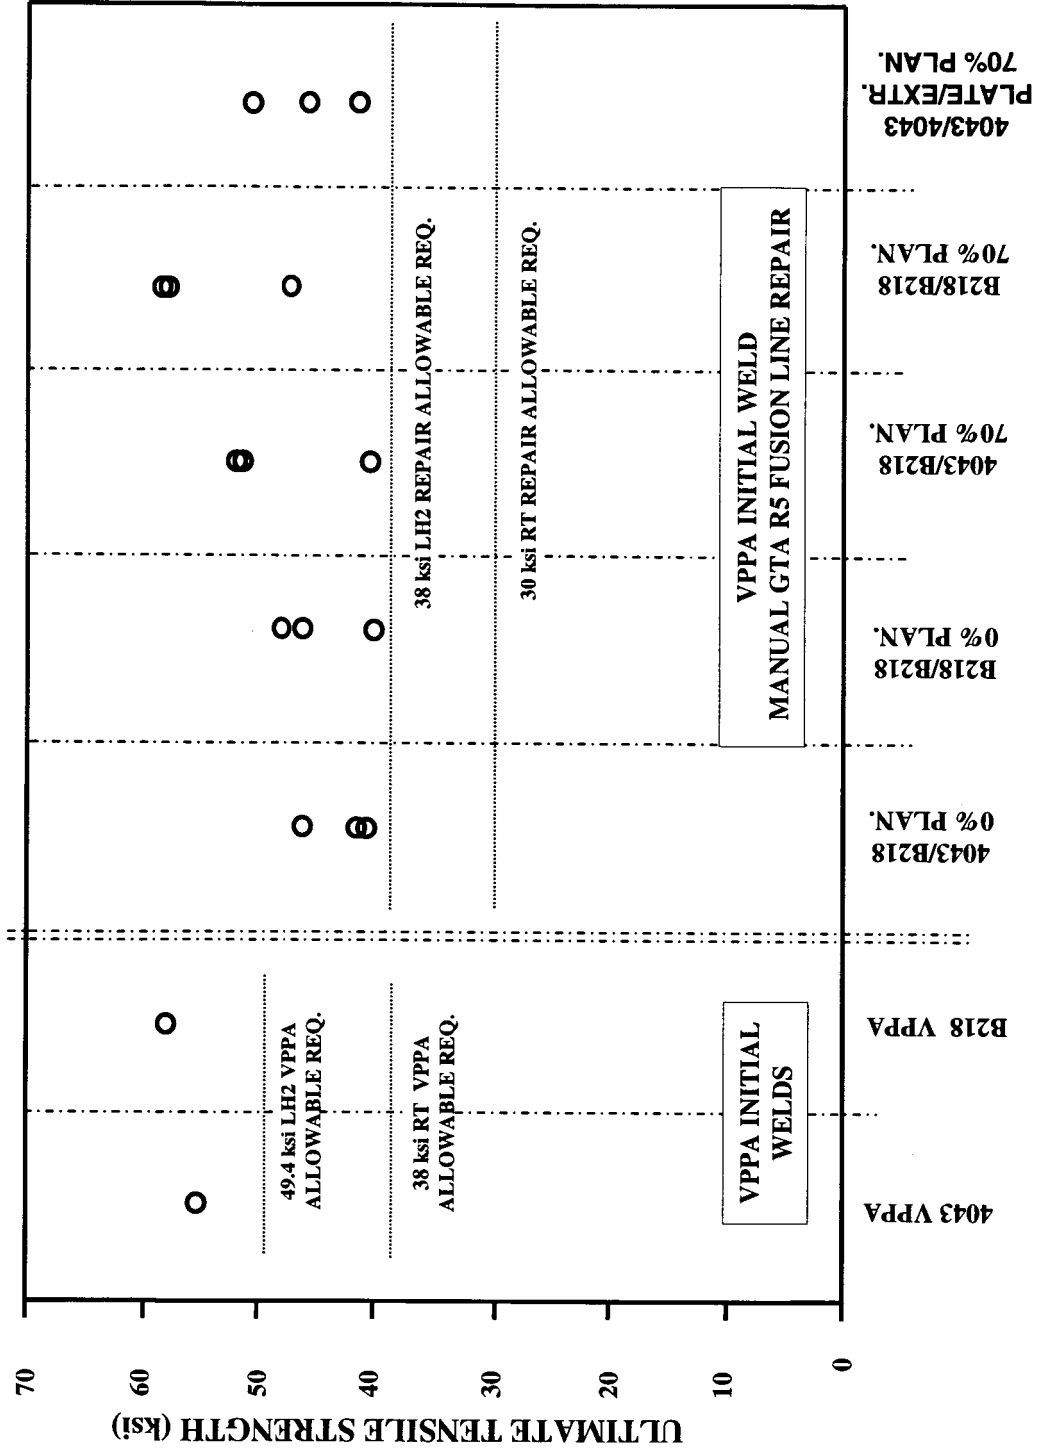
0.320t 2195T8M4 Structural Simulation Panel Weld Tensile Strength (-423°F)

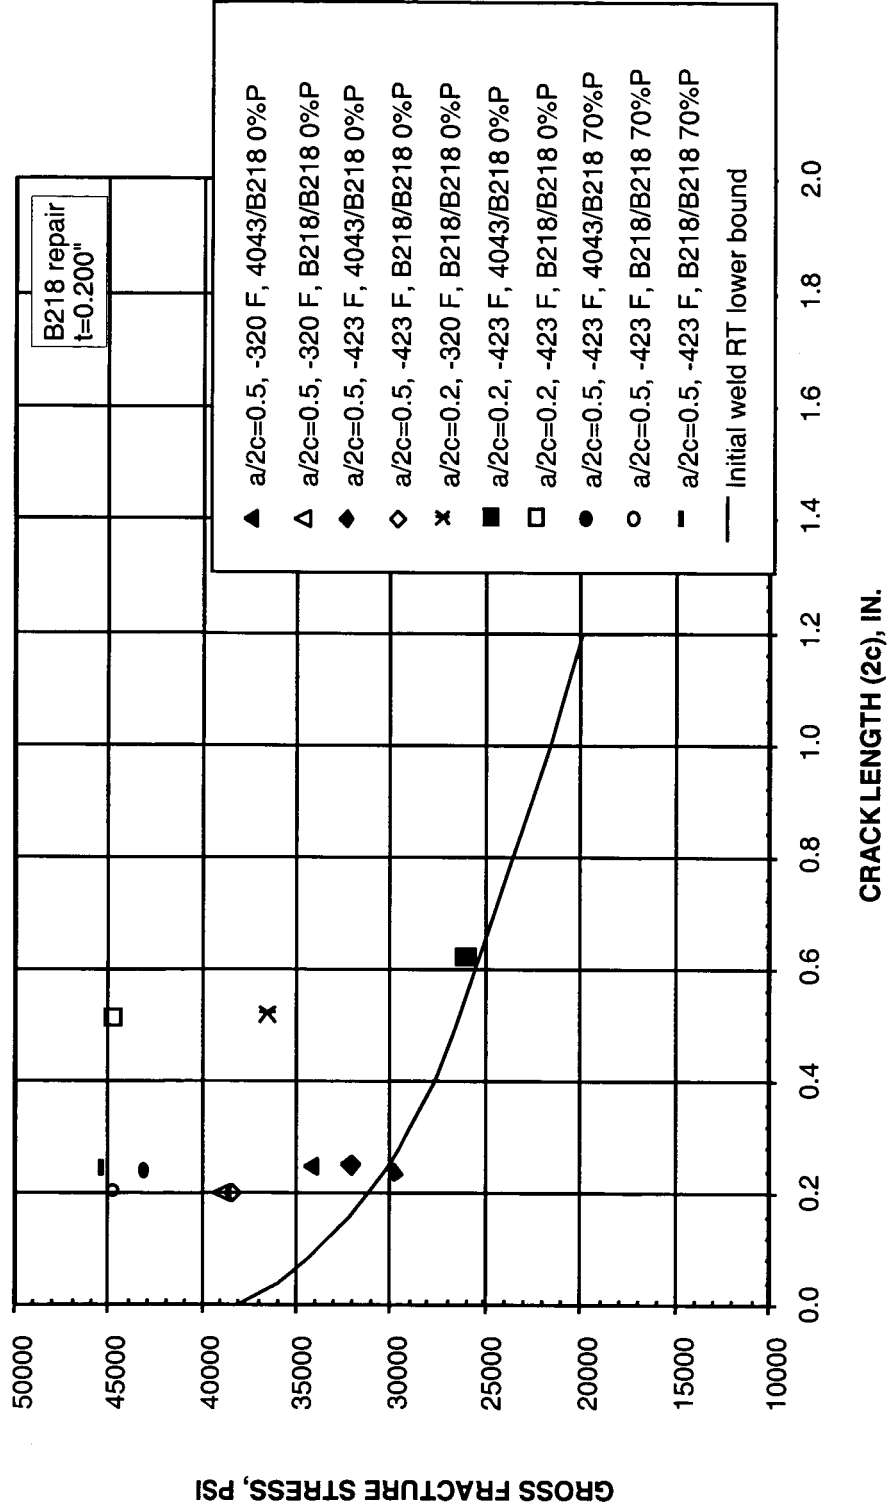
0.200t 2195T8M4 VPPA/GTA Repair Weld Simulated Service Fracture Toughness

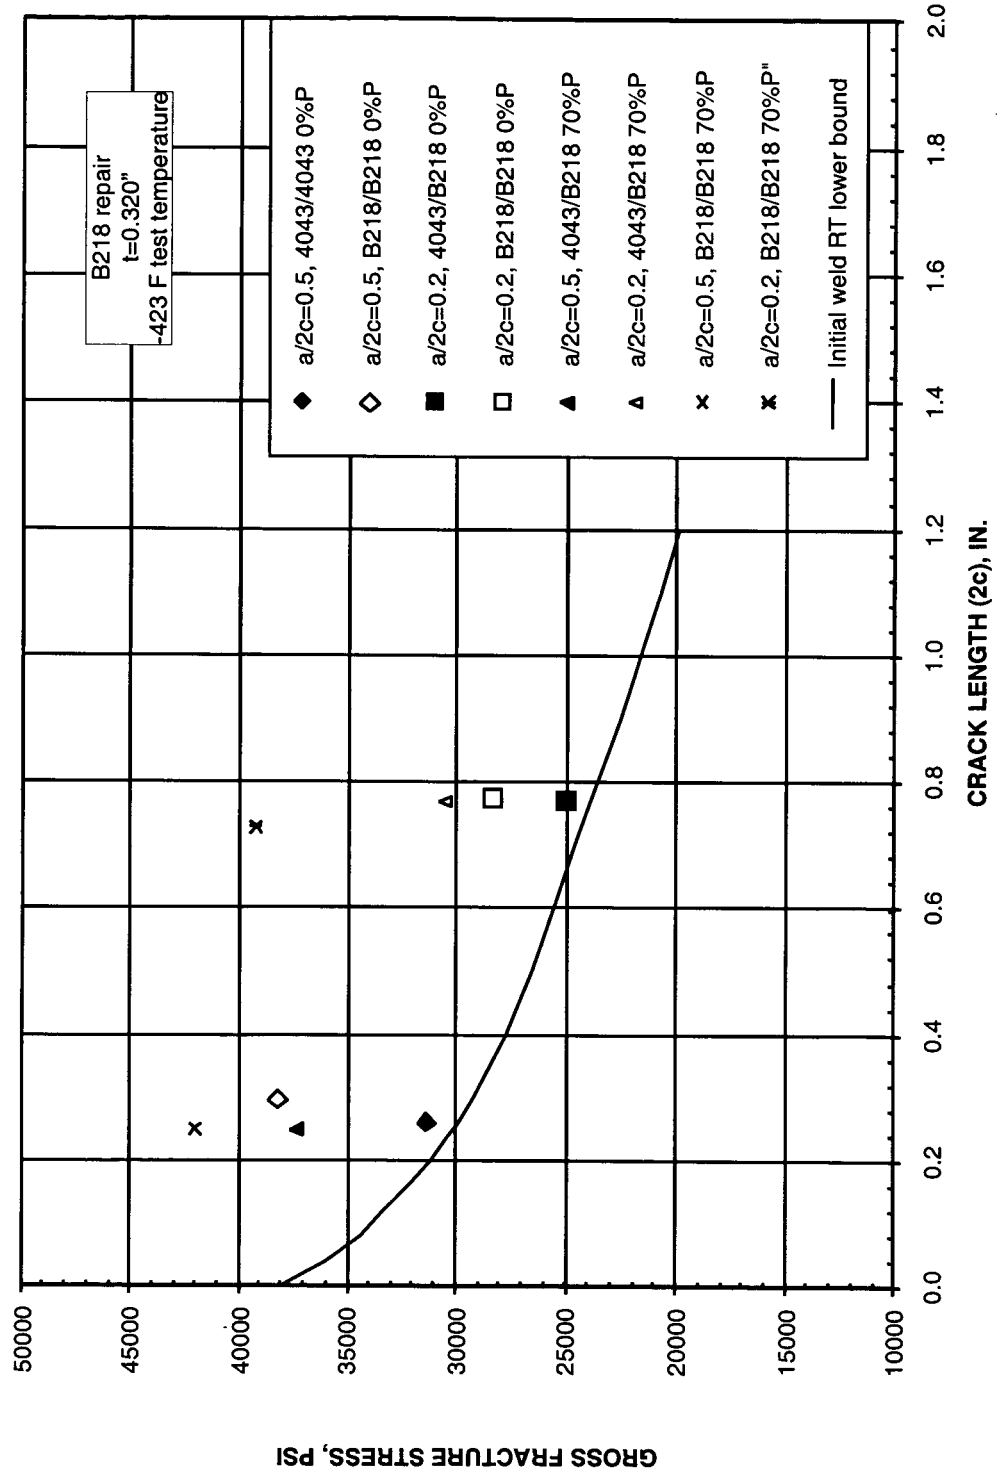
0.320t 2195T8M4 VPPA/GTA Repair Weld Simulated Service Fracture Toughness
